温熱測定結果

一倉庫の熱画像撮影一

測定期間：

2015/7/31 9:00~18:00

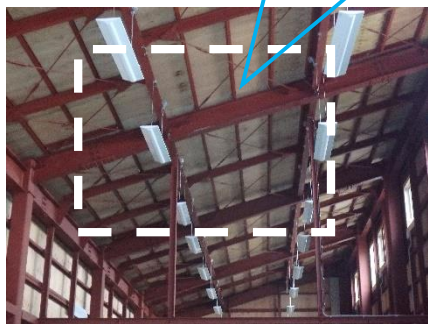
測定箇所：3点

- ・ 太陽光パネル下
- ・ 太陽光パネル間
- ・ 太陽光パネルの設置無し

パネル部分とパネル無し部分との間に最高で**約10°C**の温度差あり

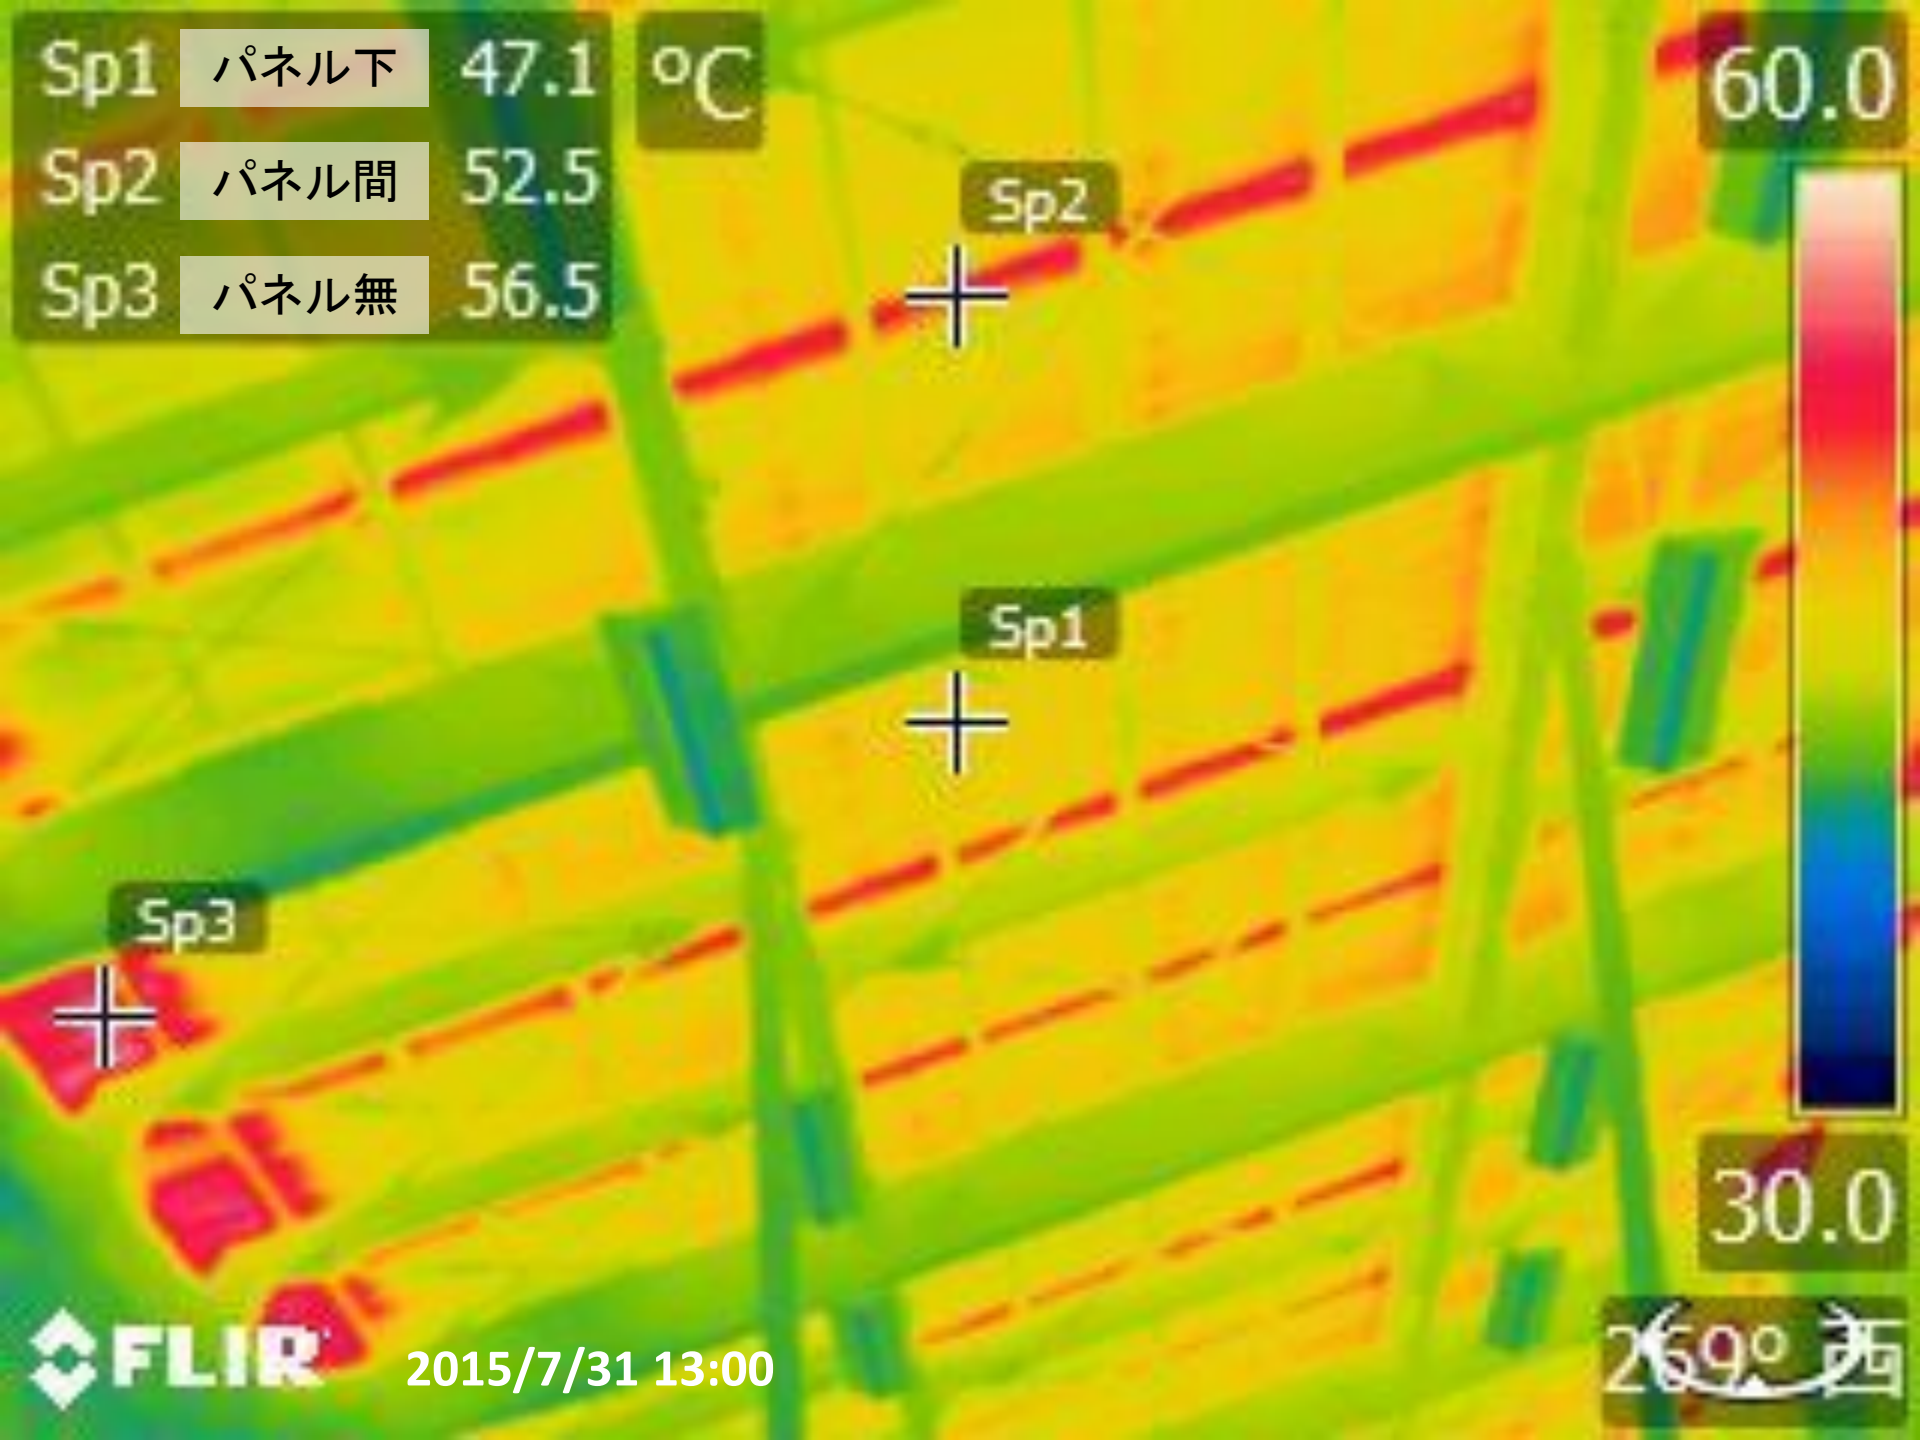
2015/7/31 13:00

Sp1 パネル下 47.1 °C

Sp2 パネル間 52.5

Sp3 パネル無 56.5

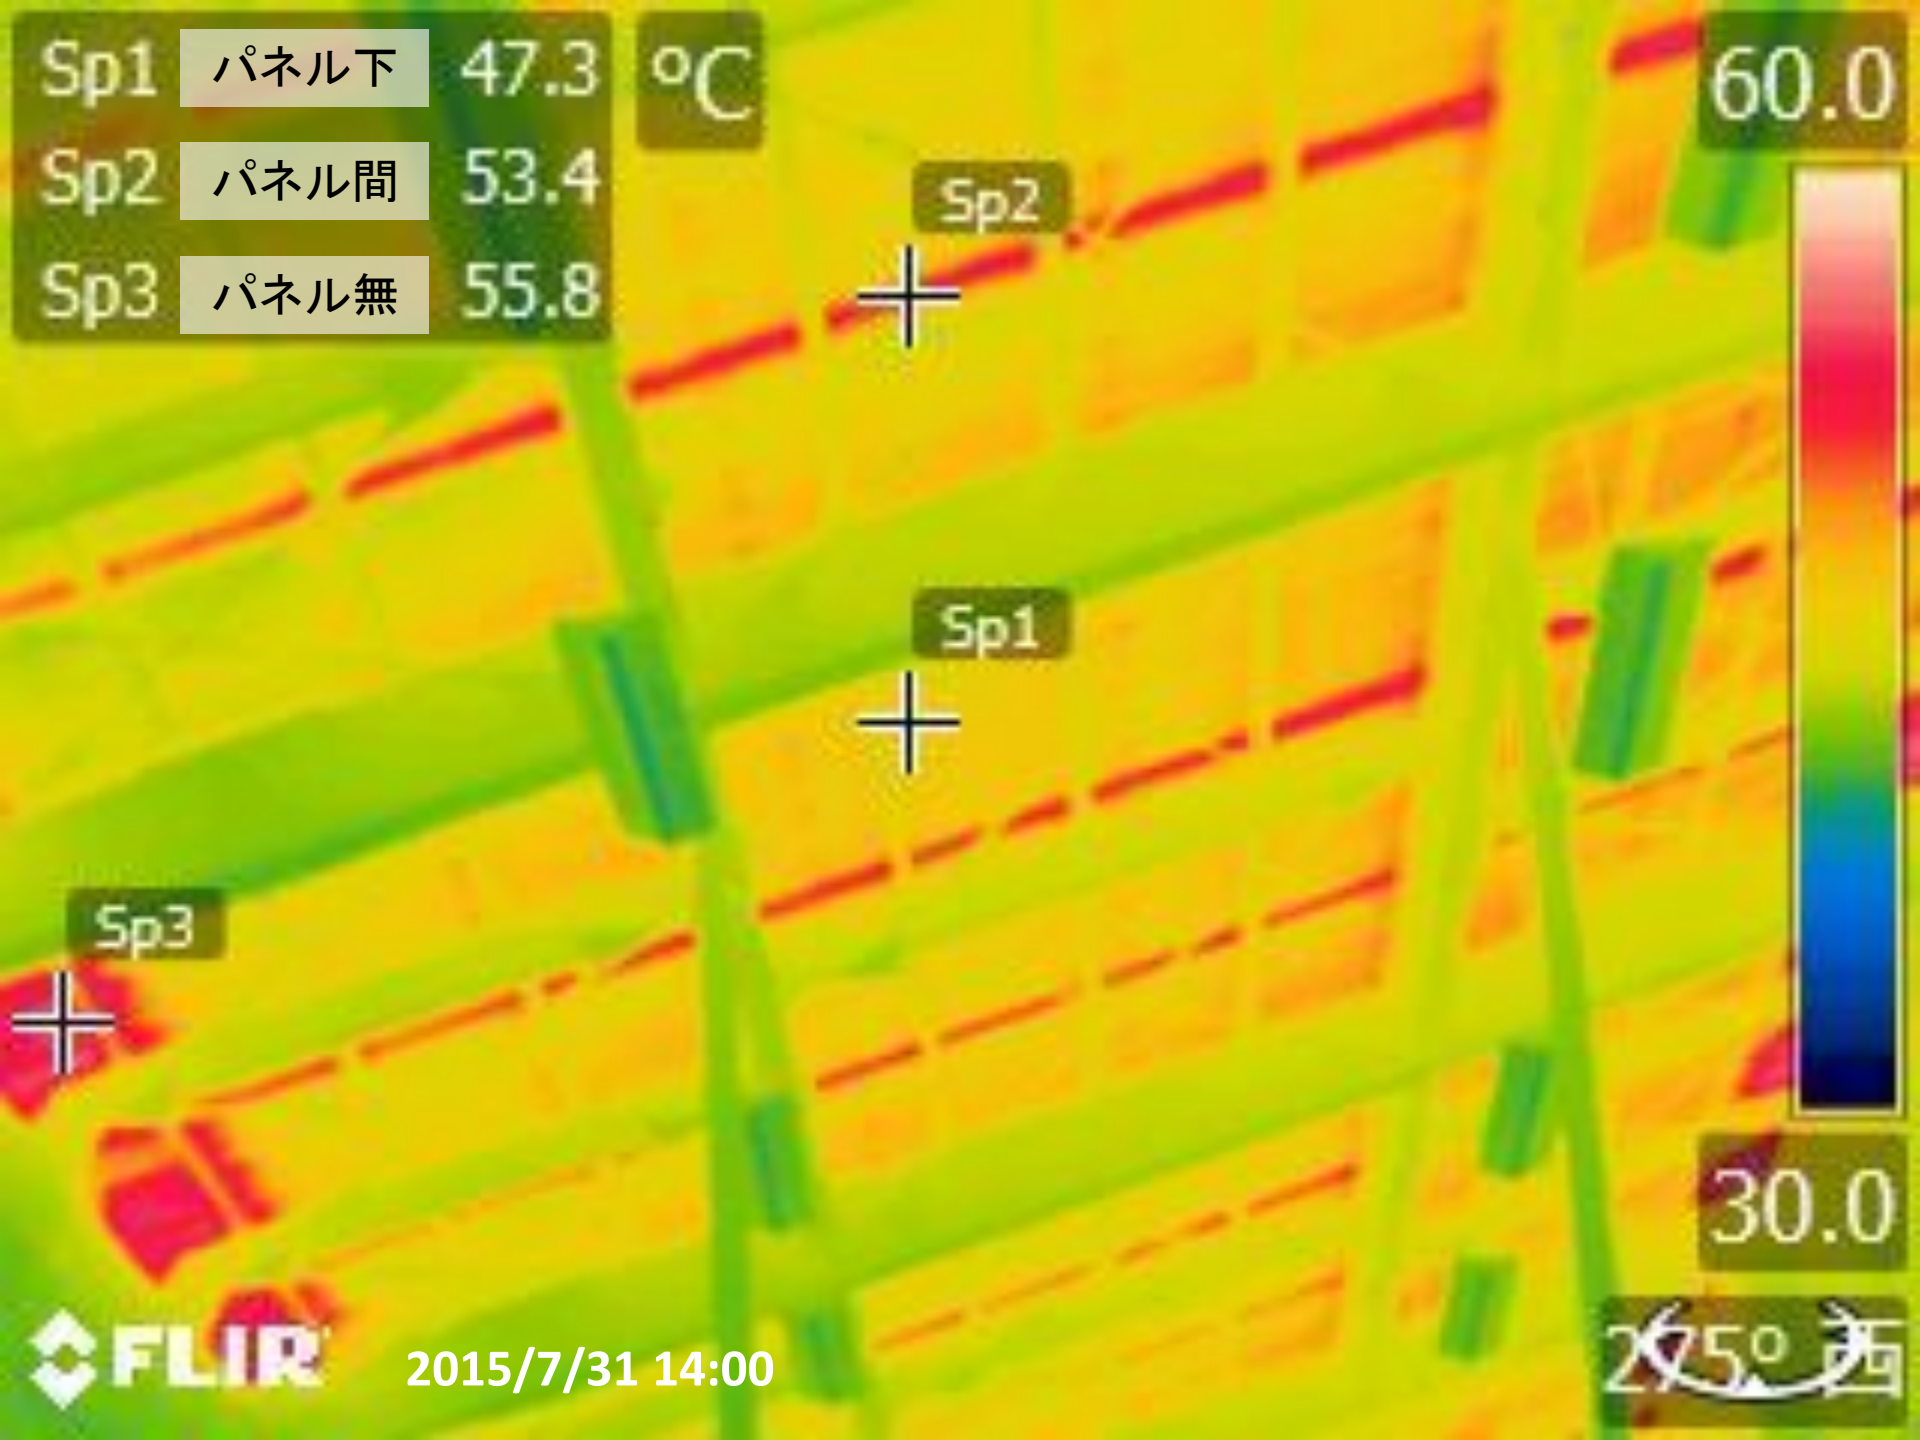
2015/7/31 14:00

Sp1 パネル下 47.3 °C

Sp2 パネル間 53.4

Sp3 パネル無 55.8

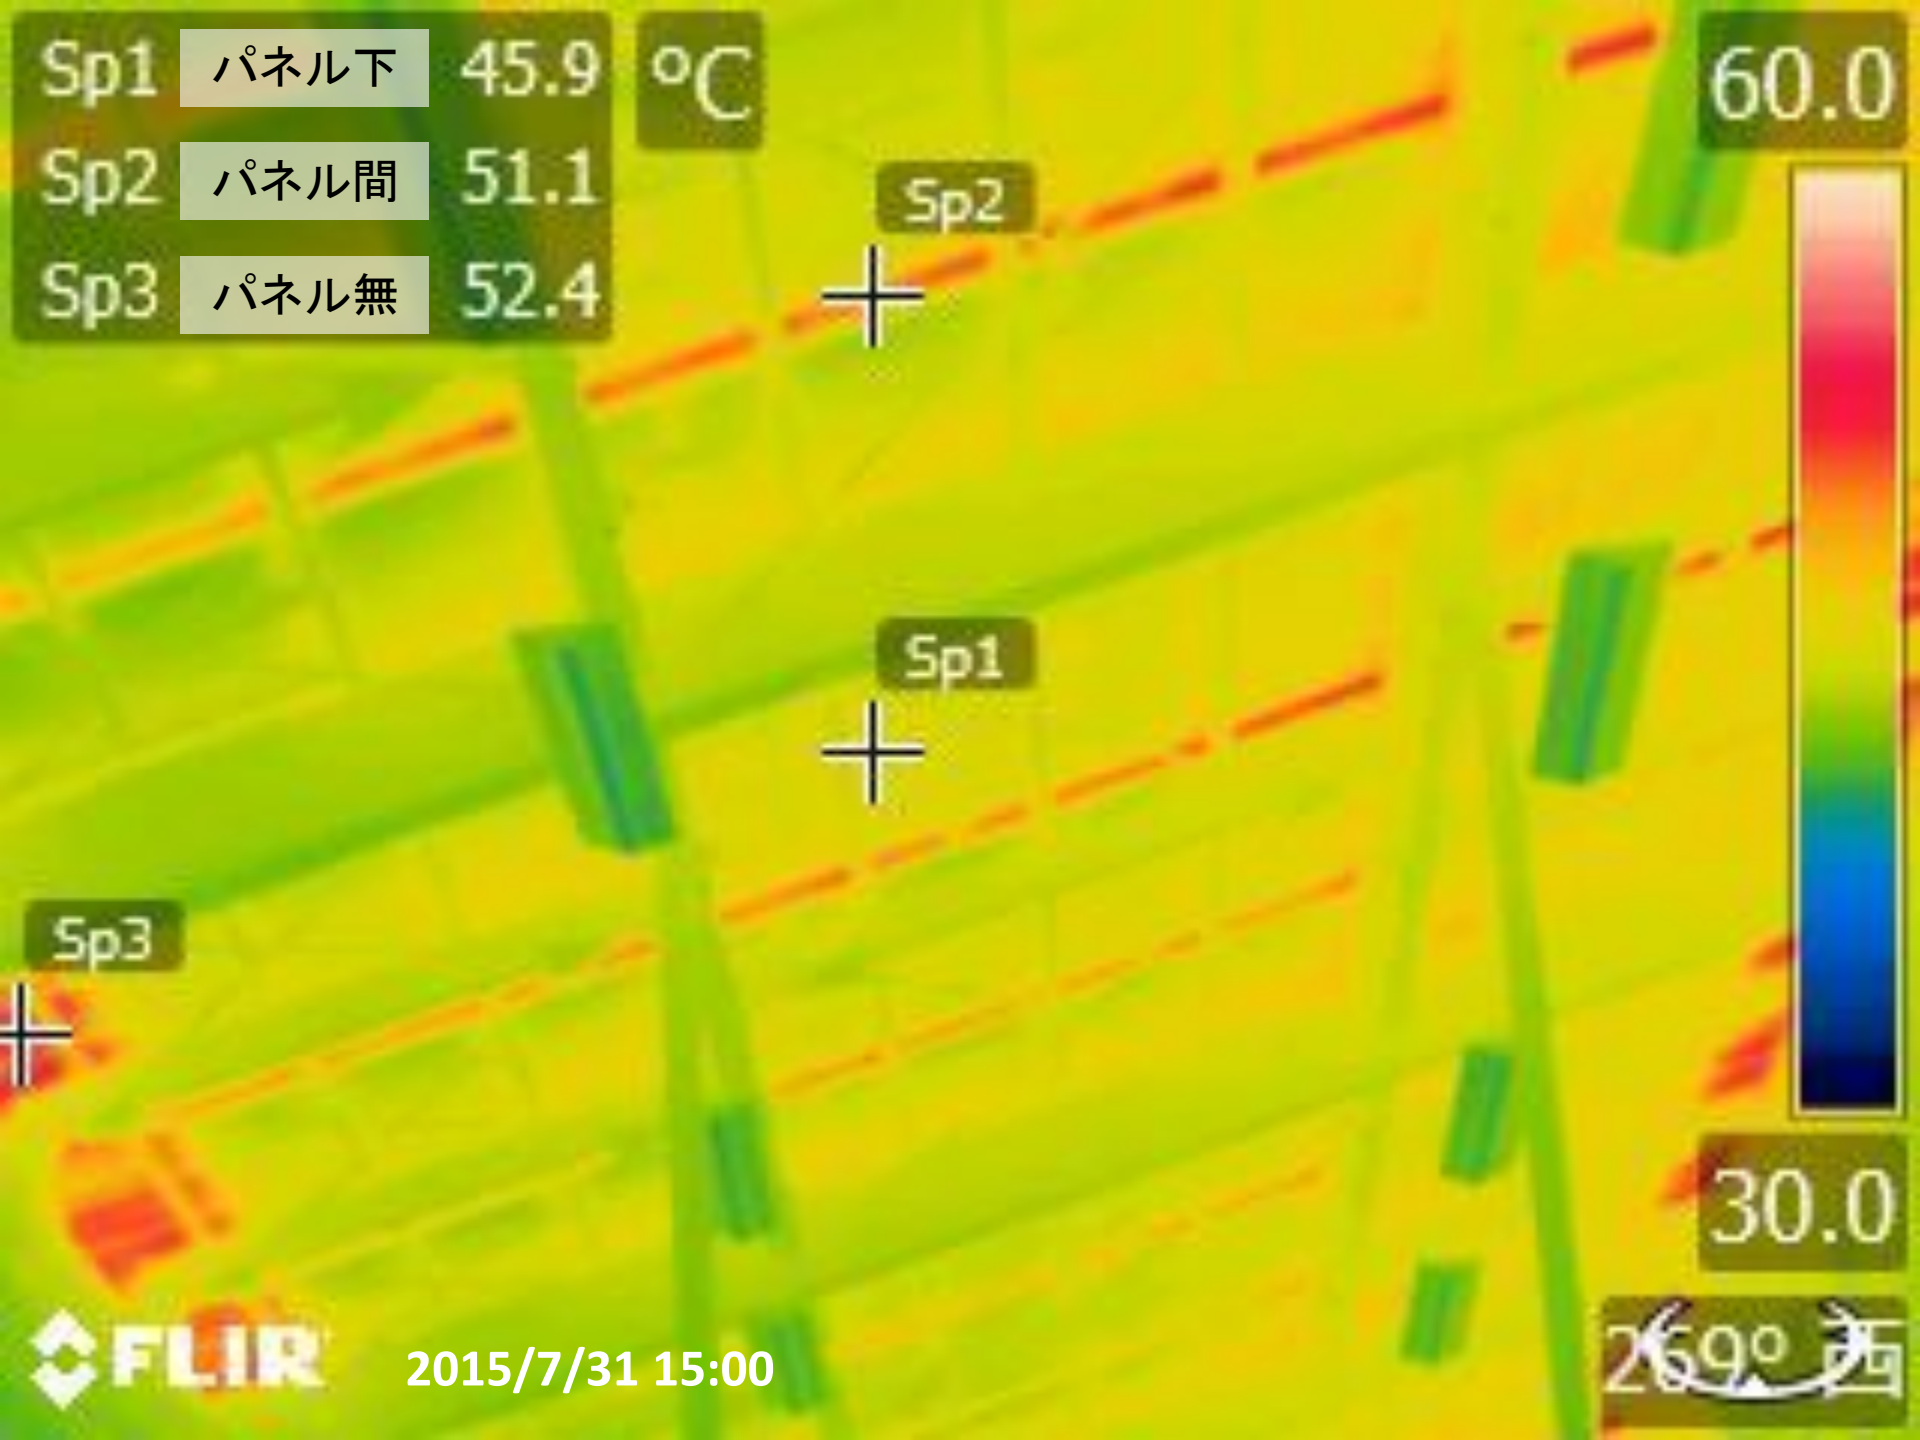
2015/7/31 15:00

Sp1 パネル下 45.9 °C

Sp2 パネル間 51.1

Sp3 パネル無 52.4

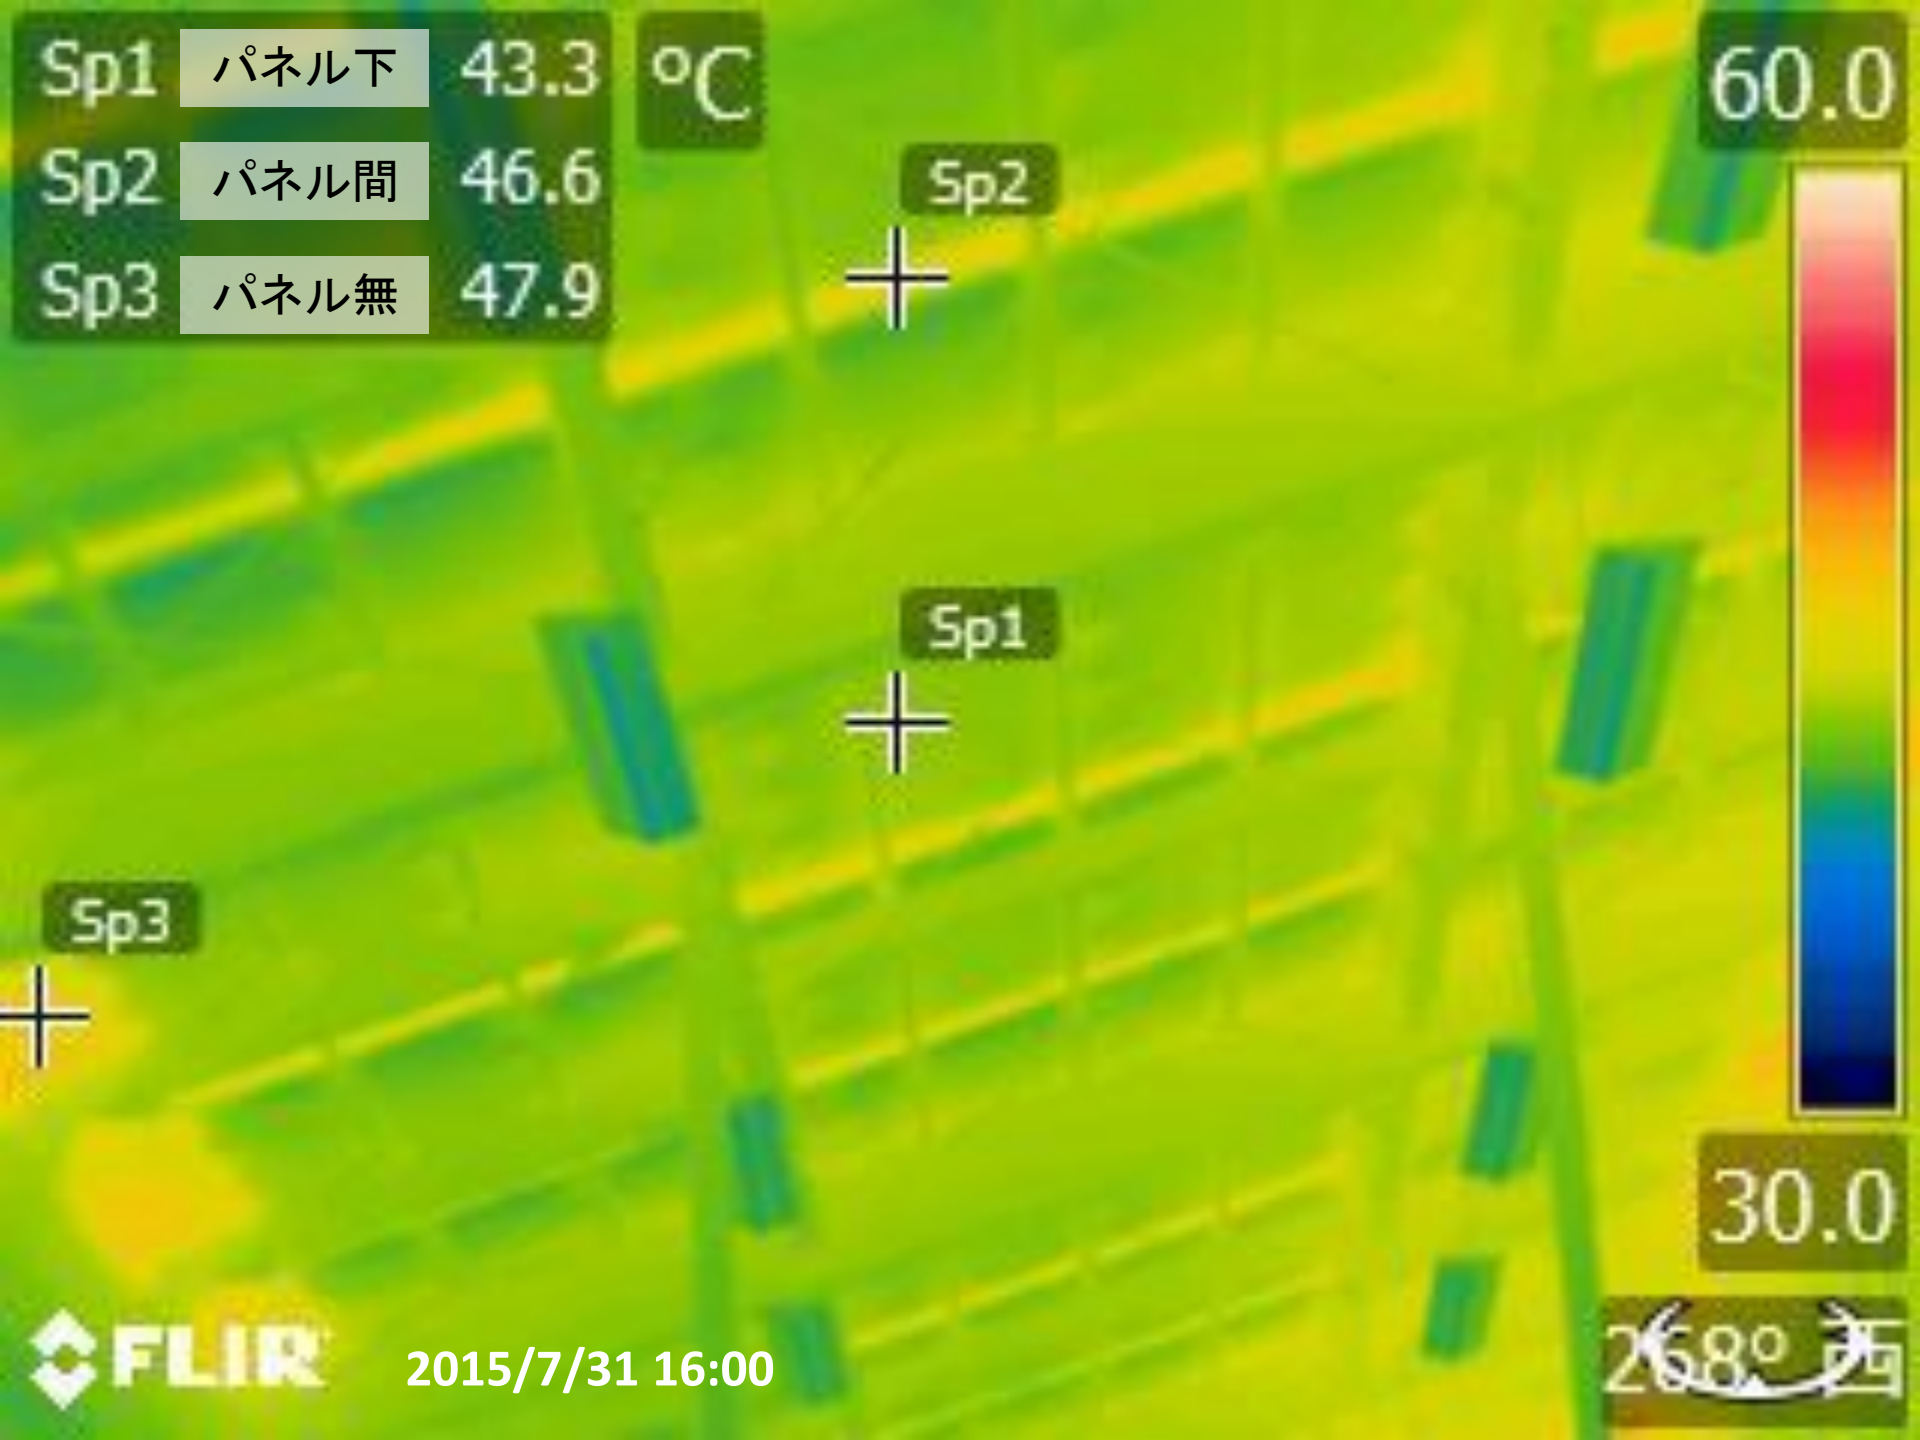
2015/7/31 16:00

Sp1 パネル下 43.3 °C

Sp2 パネル間 46.6

Sp3 パネル無 47.9
